Test Report Nº B24-16-CQ-02E

Degree of protection test IK09

TEST SAMPLE WALL READER

DESIGNATION WRDi0E4x Serie

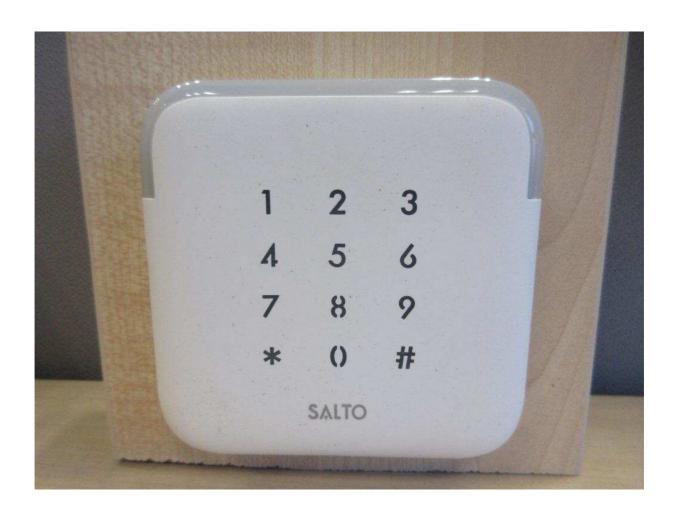
Test sample

RESULT: CORRECT. No significant damage is observed that reduces the previous tested degrees of

protection and the correct operation of the sample.
